Home Inspection Report

3 River Bluff Pl.
St. Louis, MO 63111

Prepared by: Architective Home Inspections, Ltd.
2329 Whittemore Place
St. Louis, MO 63104

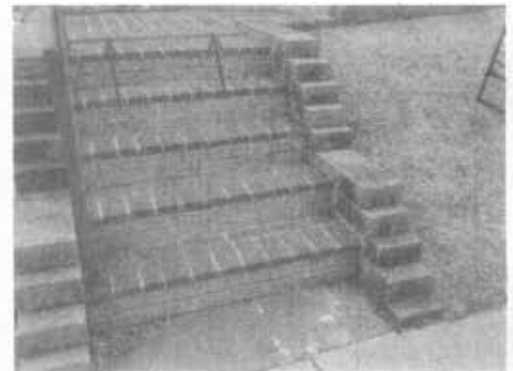
- Functional **Site Drainage/Grading** Minor slope
- Functional **Foundation Drainage/Grading** Similar to site drainage.
- Not Present **Driveway:**
- Functional **Walks, Public** Concrete.
- Marginal **Walks, Private** Concrete, brick. Approx. 1" offset in brick walkway landing at front presents tripping hazard. SEE PHOTO.

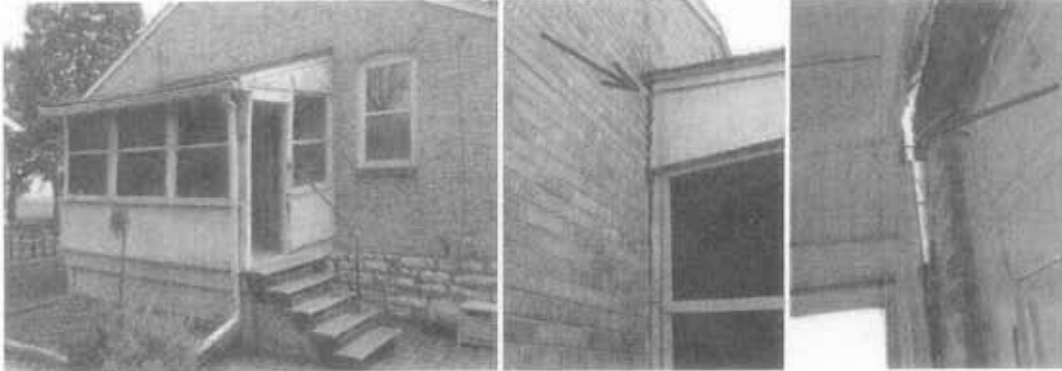
Unsatisfactory **Rear Porch** Wood frame, screened Porch structure severely deteriorated, pulling away from attachment to house. Advise removal, rebuilding. SEE PHOTOS.

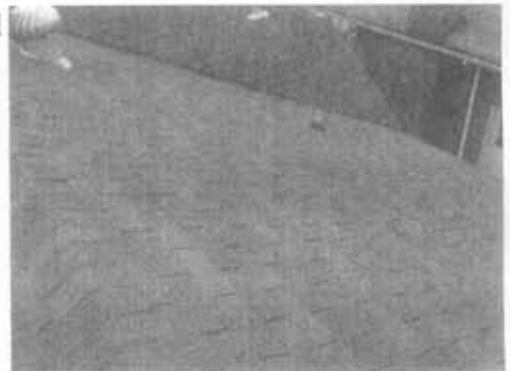
Marginal **Material:** Fiberglass shingles, 1 layer. Exhibits minor hail damage in a few spots.

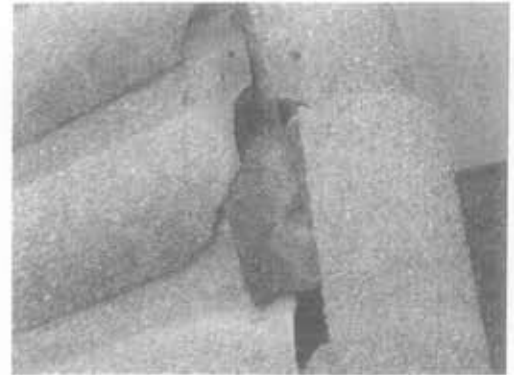
Unsatisfactory **Material:** Cement asbestos Spanish tile. Tiles pulling apart, wood substrate exposed, water damage. Consult qualified tile roofing contractor for further review and repairs as needed. SEE PHOTO.

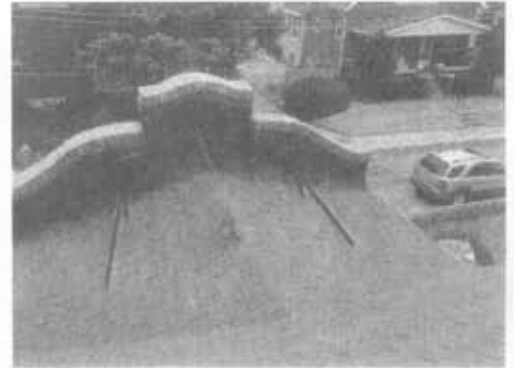
Unsatisfactory **Flashing:** Metal and mastic. Apparent leakage through large mastic flashing area behind south wall front parapet and low shingle roof behind. Dampness or active leakage detected in attic space and at interior plastered wall finishes below. Advise to consult qualified roofer for installation of improved flashings and repairs as required. SEE PHOTO.

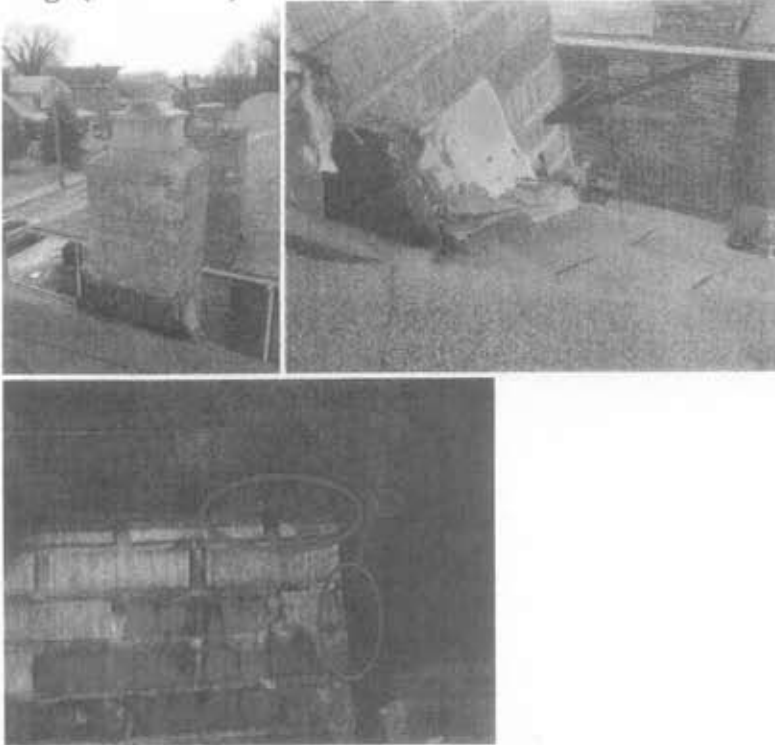
Unsatisfactory **Chimney Flashing:** Copper, aluminum, mastic, roofing material. Portion of copper counterflashing missing from north side of chimney base. Active leakage detected in damp roof sheathing in attic space under chimney. SEE PHOTOS.

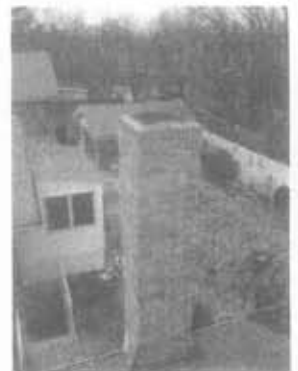
Marginal **Flue/Flue Cap:** No rain cap installed. Flue opening covered with galvanized wire mesh. Installation of cap and screen recommended at open flue pipe.

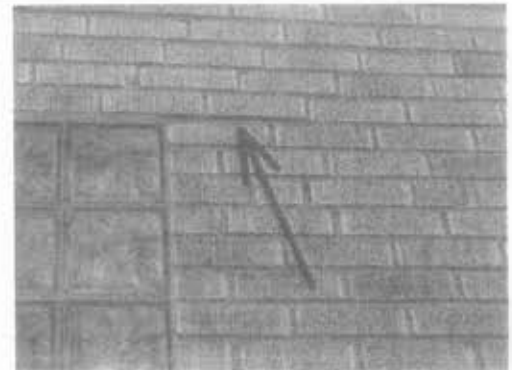
Functional **Type:** Solid masonry brick Rusting steel lintels above window openings causing uplift of brick and cracking of mortar above window openings at front bedroom south and square top windows on west side. SEE PHOTO.

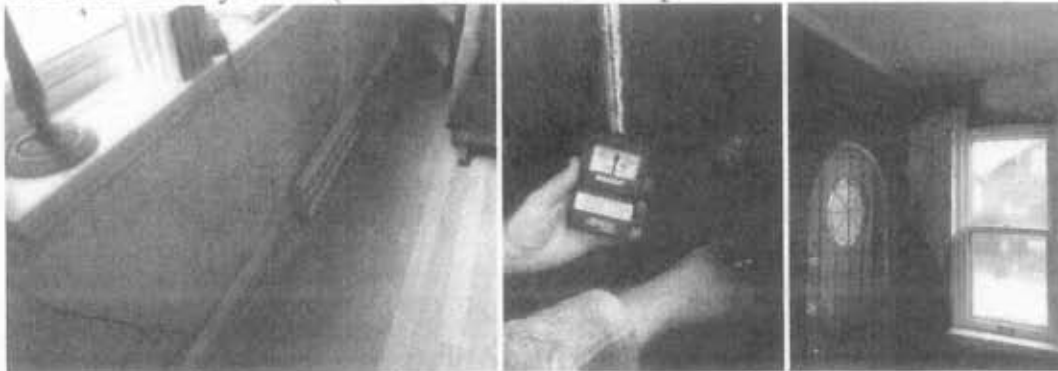
- Functional **Closet:** Various locations.
- Functional **Ceiling:** Plaster, glued on acoustical tiles.
- Unsatisfactory **Walls:** Plaster. Extensive moisture damage to plastered outside walls, particularly on east and south side of living room, south wall in front bedroom. Damaged areas extensively probed with moisture detector. Abnormal dampness found in portion of wall adjacent to living room entry door and near southeast corner of front bedroom by exterior door to porch. SEE PHOTOS. Dampness at these areas may be result of faulty flashing material at front parapet wall. Dampness also detected in attic area directly above (see "Attic" section of report).
